WORLD REPORT 2014-2015 ON MONUMENTS AND SITES IN DANGER

The Historical Museum, Sarajevo

The structure's condition in 2016

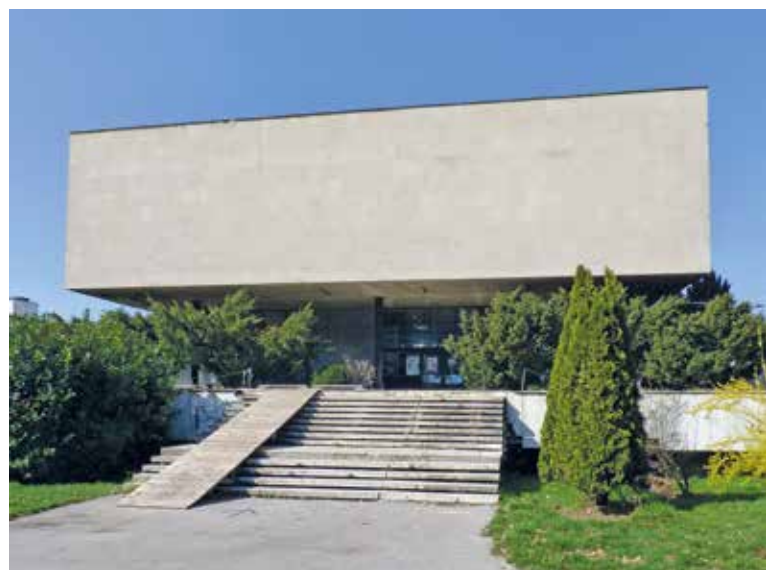
The composition is dominated by the cube – the main exhibition space positioned on a strong pedestal

The composition of the structure consists of three volumes: a dominant "hovering" exhibition cube, a smaller cube with offices, and a linear glazed corridor (with multifunctional halls), which connects them. The entire composition is laid on a white stone pedestal, thus being an early example of an urban gallery/terrace open towards the museum quarter. At the same time, the pedestal enables the creation of a delimited garden at the back façade – a reminiscence of the unbreakable bond between the traditional urban dwelling and the greenery.

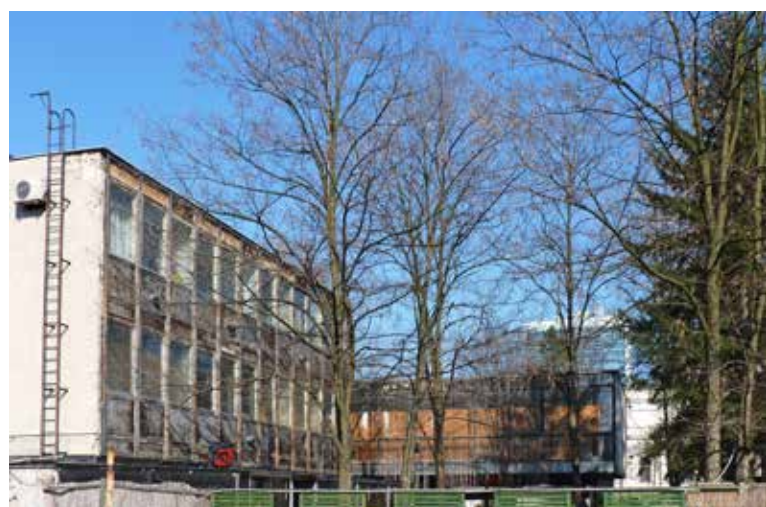
The smaller cube, much more modest and intended to house the museum's management (photo 2016)

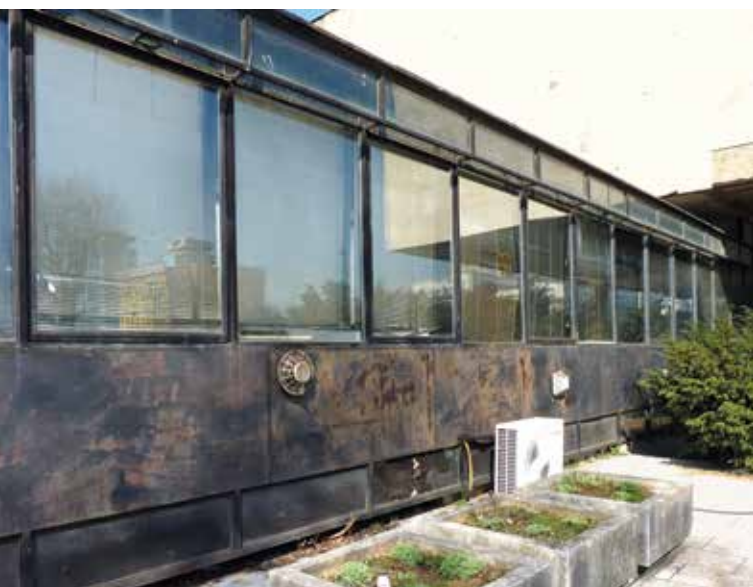
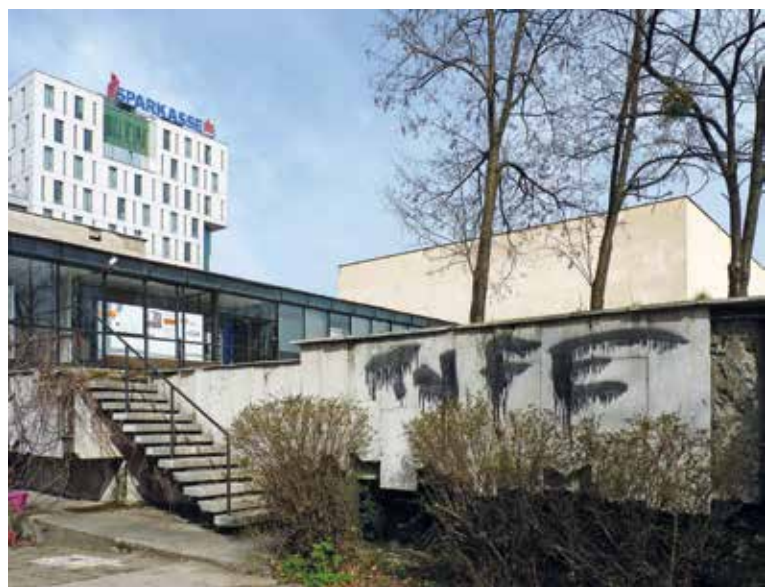
Steel construction with obvious and very advanced corrosion; stone surfaces also showing severe damage (photos 2016)

During the war activities in the early 1990s, the Museum's structure was at the frontline, which caused significant devastation, both physically and functionally. After the end of the war, due to political reasons the status and funding of the Museum were not adequately solved. Because of the lack of thorough renovation and regular maintenance, the building rapidly fell into disrepair. Although experts have evaluated this building as an exceptional achievement of 20th century architecture, relevant institutions have not yet undertaken appropriate measures in order to prevent its present condition.

Bearing in mind that interventions so far have been made provisionally and at random, the design intended to be prepared by ICOMOS Bosnia and Herzegovina would be based on the compilation of an expert designing-conservation documentation that would include:

- detailed information about the building;
- description of the current condition of the building, including an analysis of any structural and/or material deficiencies and conservation needs;

- detailed description of the proposed conservation planning, including types of research and analysis (historic, technical, or scientific);
- objectives and expected outcomes and a rationale for each component;
- detailed information about specialists involved in the project (including the principal consultants, architects, engineers, scientists, researchers, conservators, surveyors, project supervisor who will be overseeing the architect(s), design and construction dates, etc), their roles and responsibilities, and their qualifications to undertake the project;
- in addition, images illustrating the exterior and interior of the building, including depictions of its location, architectural details, and past and present condition would be included. That photo documentation would demonstrate the continuous deterioration of the building.
